NDE of hidden flaws in aging aircraft structures using obliquely backscattered ultrasonic signals (OBUS)

Yoseph Bar-Cohen^a, Ajit K. Mal^b, and Marvin Lasser^c

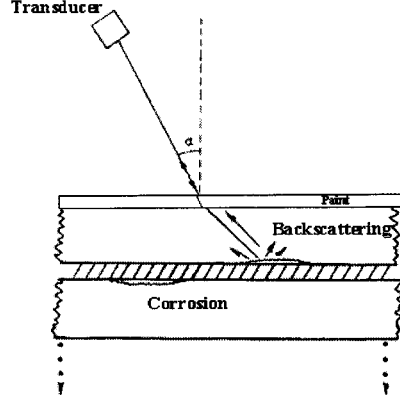
Figure 3: Oblique backscattering ultrasonic waves (OBUS) setup.

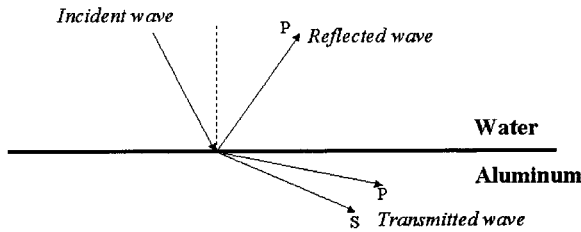
Figure 4: Reflected and transmitted energy flux coefficient for water/aluminum interface.

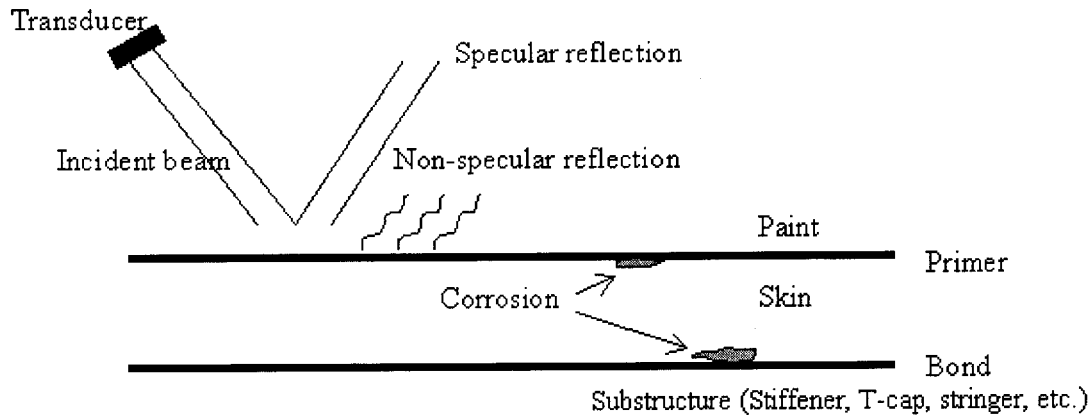
Figure 5: A schematic view of the wavefield in a painted 2-layer structure.

The basic theoretical model is depicted in Figure 5, where the ultrasonic wave is incident upon the multi-layered aircraft structural component shown. As indicated earlier, if there is no corrosion or other damage to the material, the wave interaction with the structure results in specular and non-specular reflections and no reflected energy is returned to the transmitting transducer. For flat layered or slightly tapered geometry, the reflected wavefield can be calculated by means of available standard techniques. If corrosion damage or other localized defects are present within the layered structure, then the waves are scattered by the defect and the scattered waves propagate away from the defect in all directions. Thus a portion of the scattered wave propagates back to the transmitting transducer. The location, shape and size of the flaw influence the characteristics of this backscattered wavefield, and a careful analysis of the backscattered wave can, in principle, provide information about the nature of the flaw. A hybrid finite element technique is currently being developed to solve the theoretical problem [Chang and Mal, 1998].

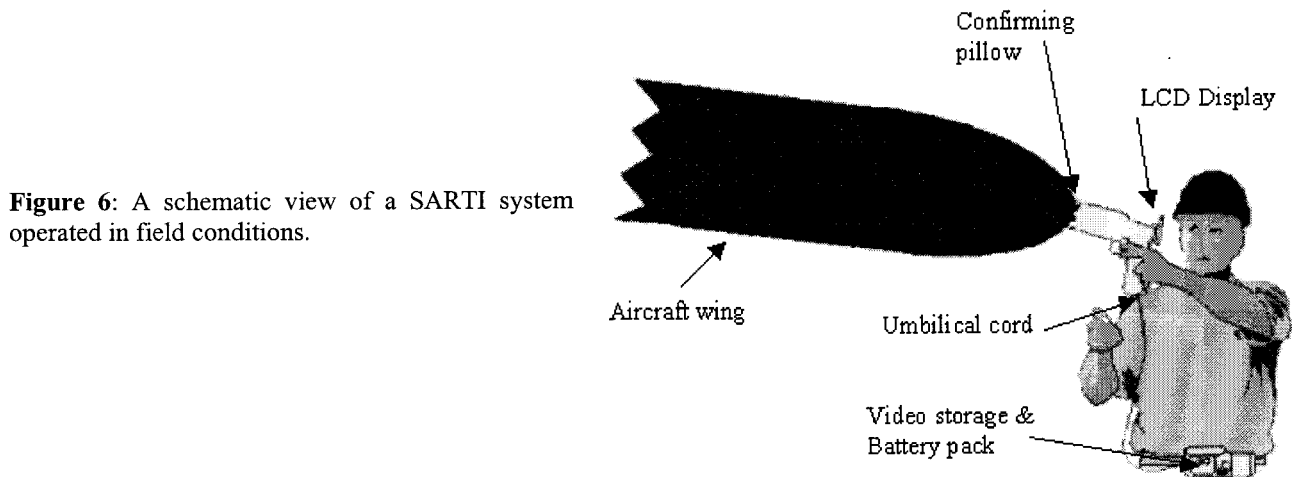
Figure 6: A schematic view of a SARTI system operated in field conditions.

The SARTI system operates as an 'ultrasonic camcorder' and it employs imaging elements that are used in mature visible and infrared technologies. The detector consists of a two-dimensional piezoelectric microelectronic array of pixels that is read by a multiplexer at a rate of 30 frames/second. Mature electronic circuitry is used to format the images for presentation to the user, similar to a standard video camcorder. The use of commercial high resolution and high sensitivity microelectronic components allows making a low cost instrument, which is benefited from the rapid improvement of these components by the industry. The SARTI transducer is a broadband type that induces a wide and relatively uniform beam. The reflected signals are collected using an acoustic lens that focus the signal onto the IC array that is made of a PVDF layer that is bonded to the silicon IC with 128x128 active elements over each 1-cm² area totaling over 16,000 elements (with 85-μ center-to-center spacing). The voltage generated at each pixel is transferred to the silicon CMOS multiplexer, which is designed to read the individual voltages sequentially, producing a TV like image. To examine array slices in the time domain, the received signals are 'range gated'. The SARTI unit can be programmed to examine time-of-flight bounds and thus producing 3D images of 'material slices'. Also, frames can be integrated to enhance the signal-to-noise or perform backscattering mapping. An RS170 TV signal is then frame-grabbed and coupled to a standard machine vision system that performs

acceptance/rejection criteria, image enhancement, false color, image annotation, etc. The separation of the receiver and transmitter signals is done electronically. The SARTI system resolution can be adjusted with a minimum of 85- μ where the test area will be limited to 1-cm². The selected ultrasonic frequency of the transmitted signals and the magnification of the image can adjust the resolution of the SARTI system.

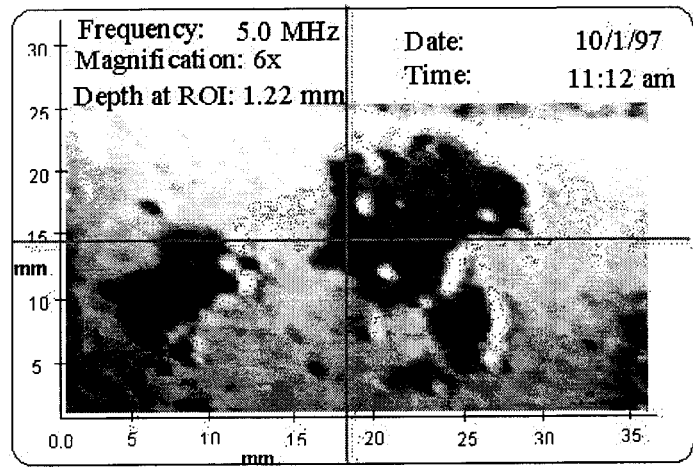
Figure 6: A pulse-echo image of corroded area in an aluminum plate visualized by the current SARTI system. The depth data represent the information at the crosshair cursor location.

frame rates. This capability contrasts the conventional C-scan, which generates the image by scanning the test area point-by-point. This real-time imaging system offers a portable, practical tool for rapid visualization of flaws using an integrated circuit, which converts ultrasound data into a standard TV output, enabling ultrasound C-scan imaging in real time. The system in its current form operates as a pulse-echo tester (as shown schematically in Figure 6) and it is designed to display different depth views by examining various ranges of time-of-flight. To employ SARTI, the inspector applies an ultrasound couplant over the desired test area. Then the probe assembly is placed against the target using the pistol grip and the ultrasonic wave insonifies the target area upon squeezing a trigger. The ultrasonic pulse-echo image of the test structure appears on a small LCD screen mounted on the back of the probe. Controls are located on the handle facing the user and real-time adjustments can be made to select the desired contrast, gain, ultrasound power, pulse-echo power, etc. An example of corrosion detected in an aluminum plate is shown in Figure 7.
